# LEARNING FROM INCIDENTS AWARENESS ALERT

September 2015

## Explosions in SMPO Hydrogenation Unit

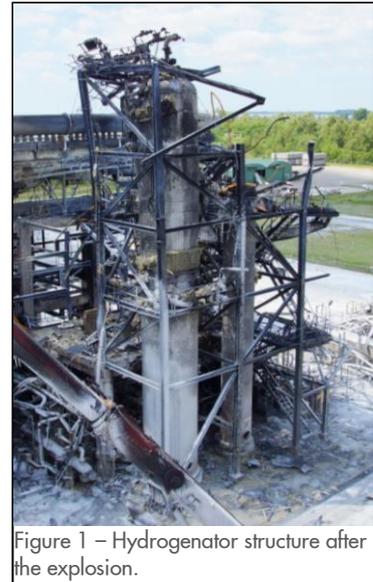
Figure 1 – Hydrogenator structure after the explosion.

The incident investigation concluded that both the reactor and vessel had failed because of overpressure, resulting from unexpected exothermic reactions between Ethyl Benzene (EB) and copper chromite oxide catalyst which produced an excessive amount of gas.

The early heat generation by the EB-chromate reaction, in combination with reduced cooling capacity in localized dry zones created localized temperatures in the reactor bed, high enough to initiate the EB-copper oxide reaction. Contributing factors include:

- The passivated copper chromite hydrogenation catalyst contains bonded oxygen in the form of copper chromate and copper oxide prior to reduction. Where a hydrocarbon and oxidizing substance (i.e. both a "fuel" and reactive oxygen) are combined and in sufficient quantities, an exothermic reaction may occur and the only mitigation available may be the total amount of cooling provided.

- A series of incremental and seemingly innocuous changes can allow unknown reactions to proceed and run out of control, resulting in a severe incident. Introduction of a new catalyst or catalyst supplier can introduce new components or changes even in small quantities of components that could lead to unidentified and unintended chemical reactions. The catalyst selection and subsequent change processes should address these with the focus on reactive hazards in both transient and steady state operations. Note that this may also apply to changes in process chemicals in other services (e.g. polymerization inhibitors, cleaning solutions, etc.).
