# **CHEMICAL INCIDENT INVOLVING A SPRAY APPLICATION OF A WATER-BASED NANO-SIZED WATERPROOFING AGENT**

# Case report

1. Case description
2. Medical treatment
3. Product properties
4. Reconstruction

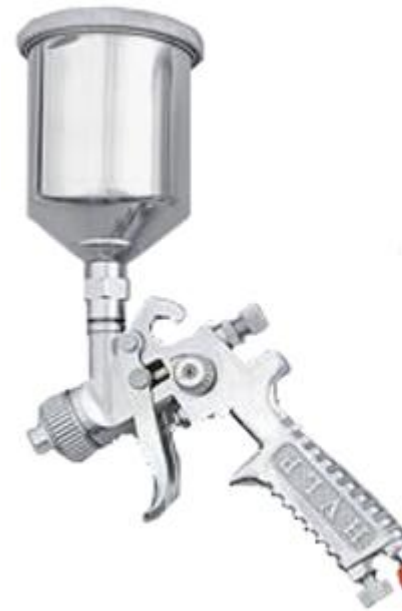
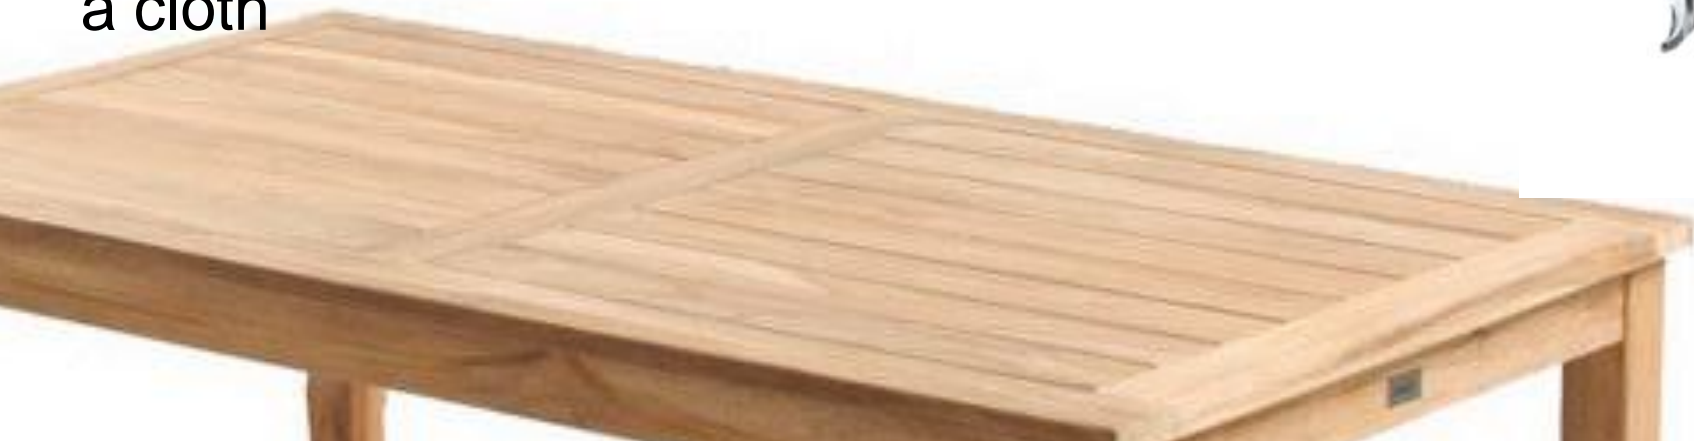
Approximately 1 liter of a waterproofing product was used in a spray gun at an air pressure of 2 atm to coat two table tops in a wood workshop of 260 m<sup>2</sup> without forced ventilation and without respiratory protection.

The label said the product is water-based and should be applied by rubbing on the surface with a cloth

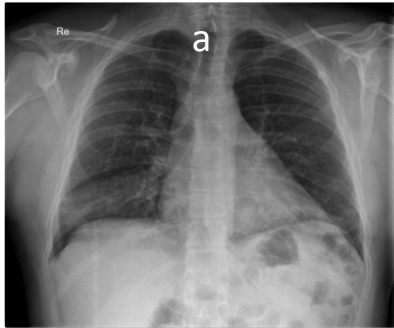
a. On the day of hospital admission

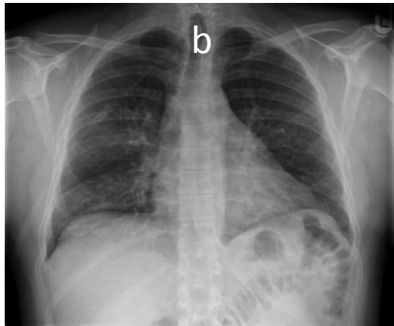
b. Infiltrative impairments and pronounced bronchovascular markings on the basal lung fields on both sides

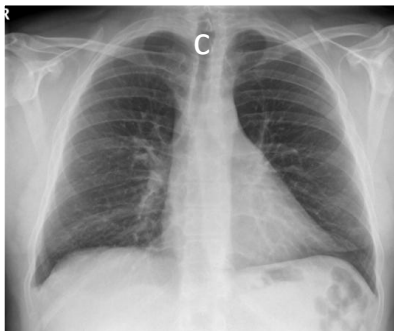
c. Complete normalization after two weeks

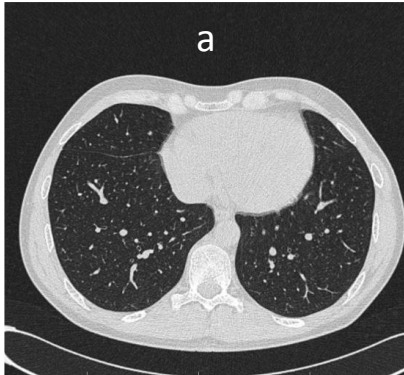
- a. Extended crazy paving of all pulmonary lobes but most pronounced in the central pulmonary region, matching pneumonitis on the second day of hospitalization

- Crazy paving of lung lobes with 'ground glass'
- This is consistent with a severe chemical pneumonitis
- This pattern is not consistent with extrinsieke allergische alveolitis

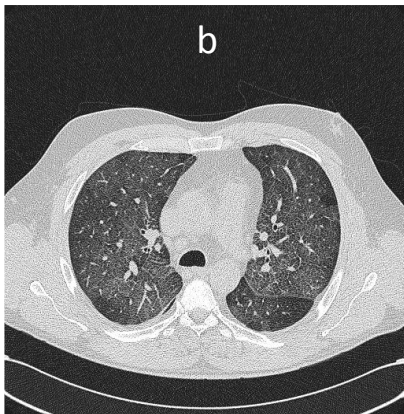
- b. Normal HRCT of the chest is shown for comparison

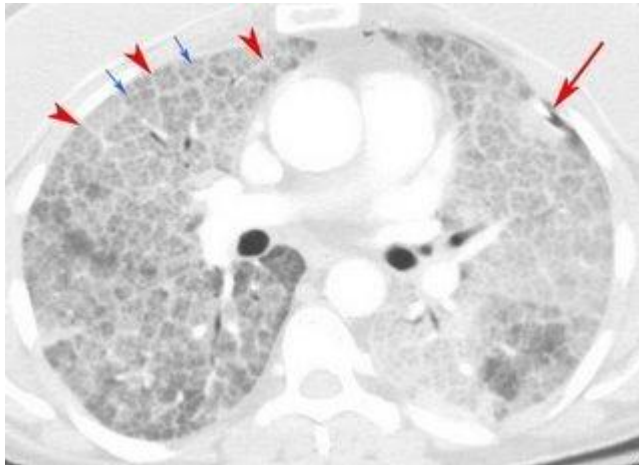
Forse crazy paving: Interlobular septal thickening and intralobular lines. Source: <http://www.radrounds.com/photo/auntminnie-crazy-paving>

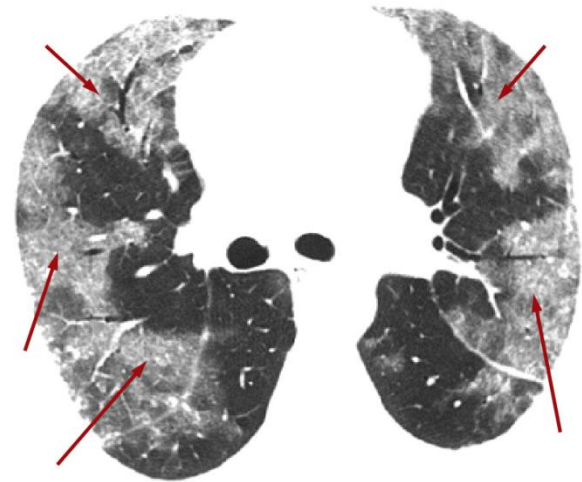
Ground glass opacities: Hazy areas of increased attenuation in the lung that have preservation of bronchial and vascular Markings. Source: [http://radiopaedia.org/articles/ground-glass\\_opacity](http://radiopaedia.org/articles/ground-glass_opacity)

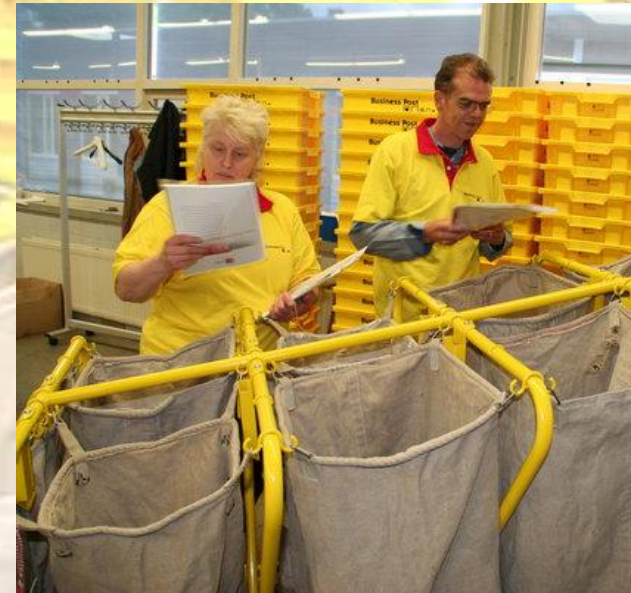
On the next morning at 8:30 am several employees in an adjacent mail distribution centre report persistent dry cough and sub-sternal pain upon physical exercise

No mist or smell was observed

At 11:00 am 9 persons have similar complaints.

Fire brigade performs measurements

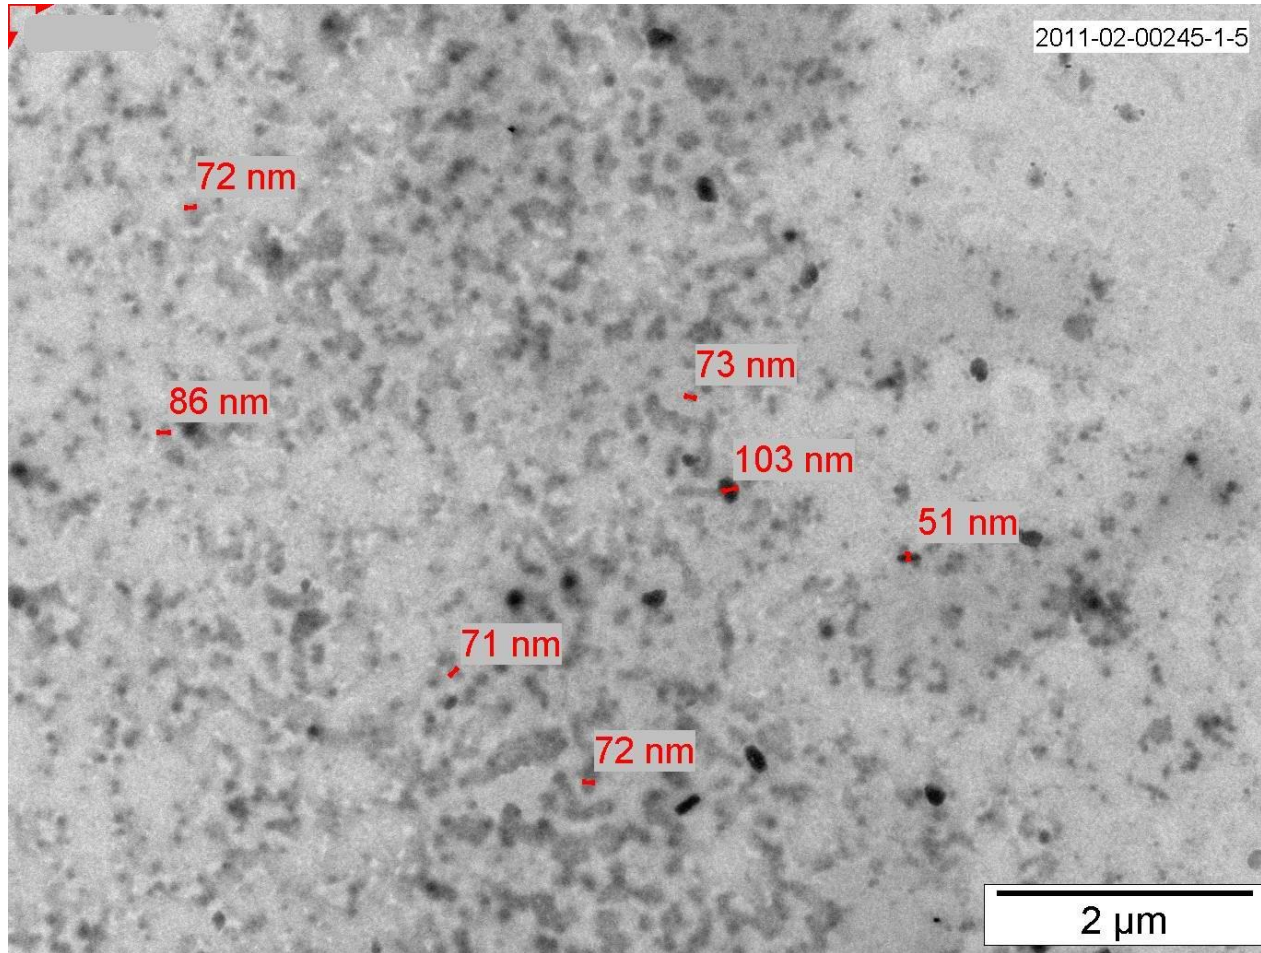
# Transmission Electron Microscopy (TEM)

The product that was used contains 1.3 wt% nano-sized spheres with a median diameter of 71-72 nm, with strong hydrophobic properties and a slight positive charge. These particles form a stable suspension in water with a negligible tendency to form clusters.

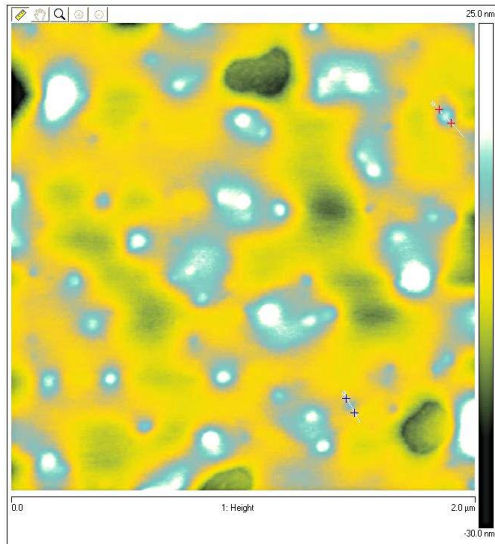
# Atomic force microscopy (AFM)

Spectral Period 0.00 μm  
Spectral RMS Amplitude 2.69 nm  
Spectral Frequency 0.00 /μm  
Temporal Freq 0.00 Hz

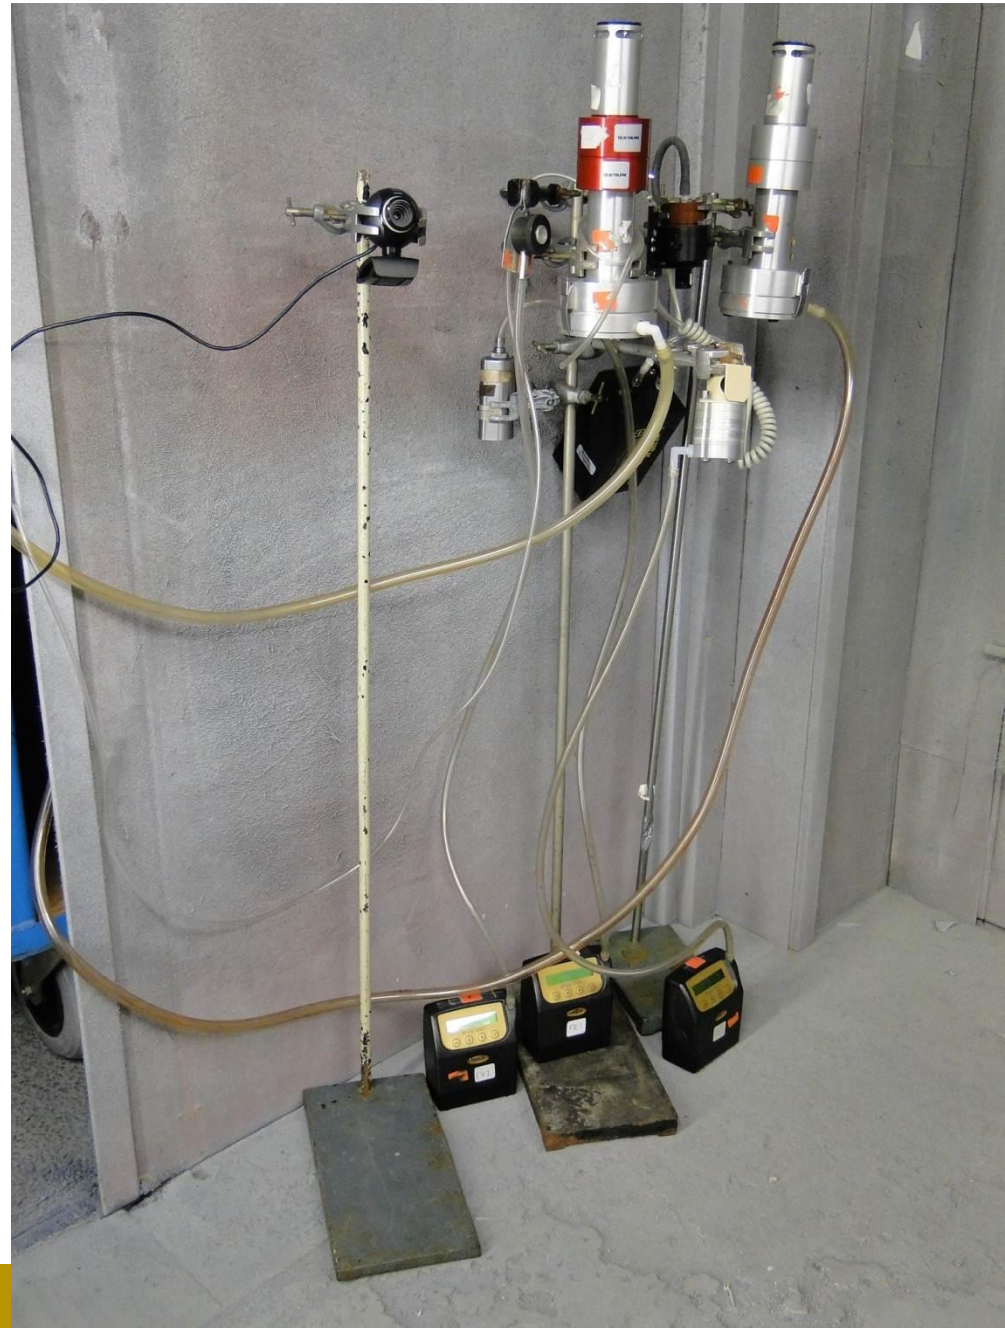
- Application of 700 ml on wood surface of 4 m<sup>2</sup>
- Eminent type E31 EHT M01 spray gun
- Approx. 2 atm air pressure
- Duration ca. 10 minutes
- Spray booth
- PPE: P3 mask and gloves

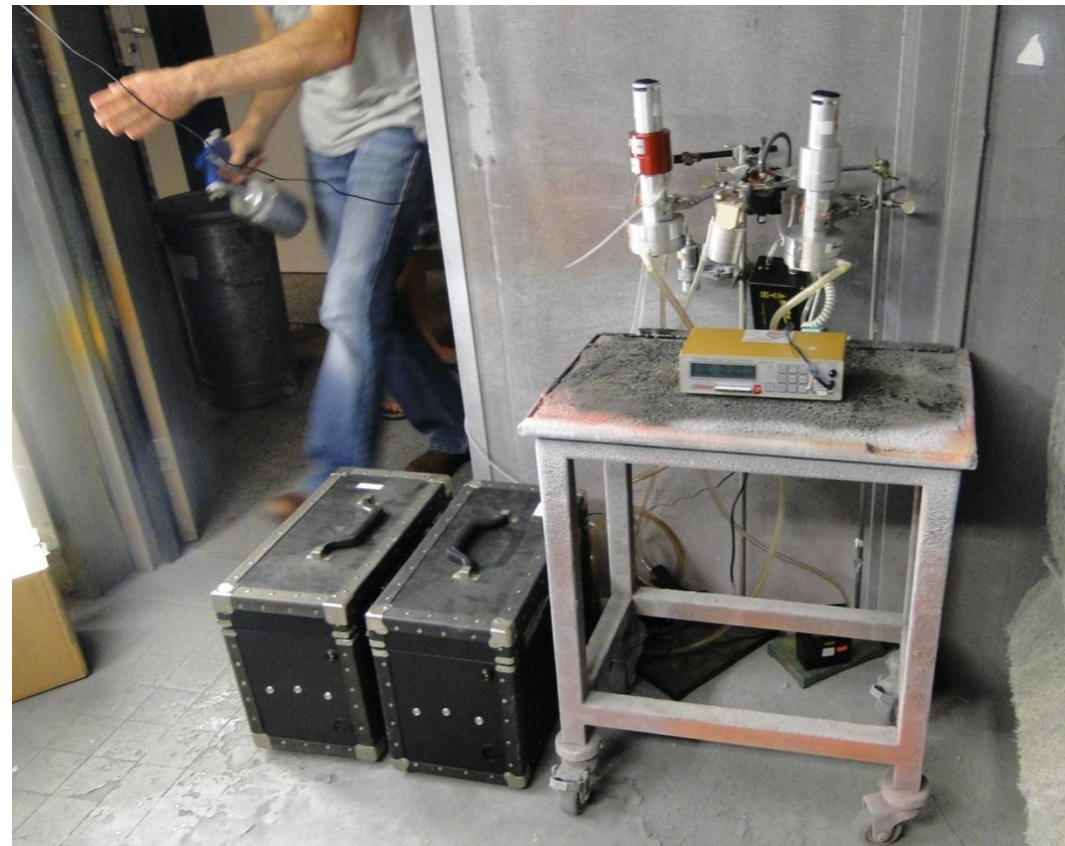
- Filter samples:  
Inhaleerbaar, thoracic (PM-10), respirabele (PM4) and PM-2.5
- Cascade impactor:  
8 stages
- Light scattering:  
Grimm 1.109 (0.25-35  $\mu\text{m}$ )  
OSIRIS  
Hazdust (PM-10)

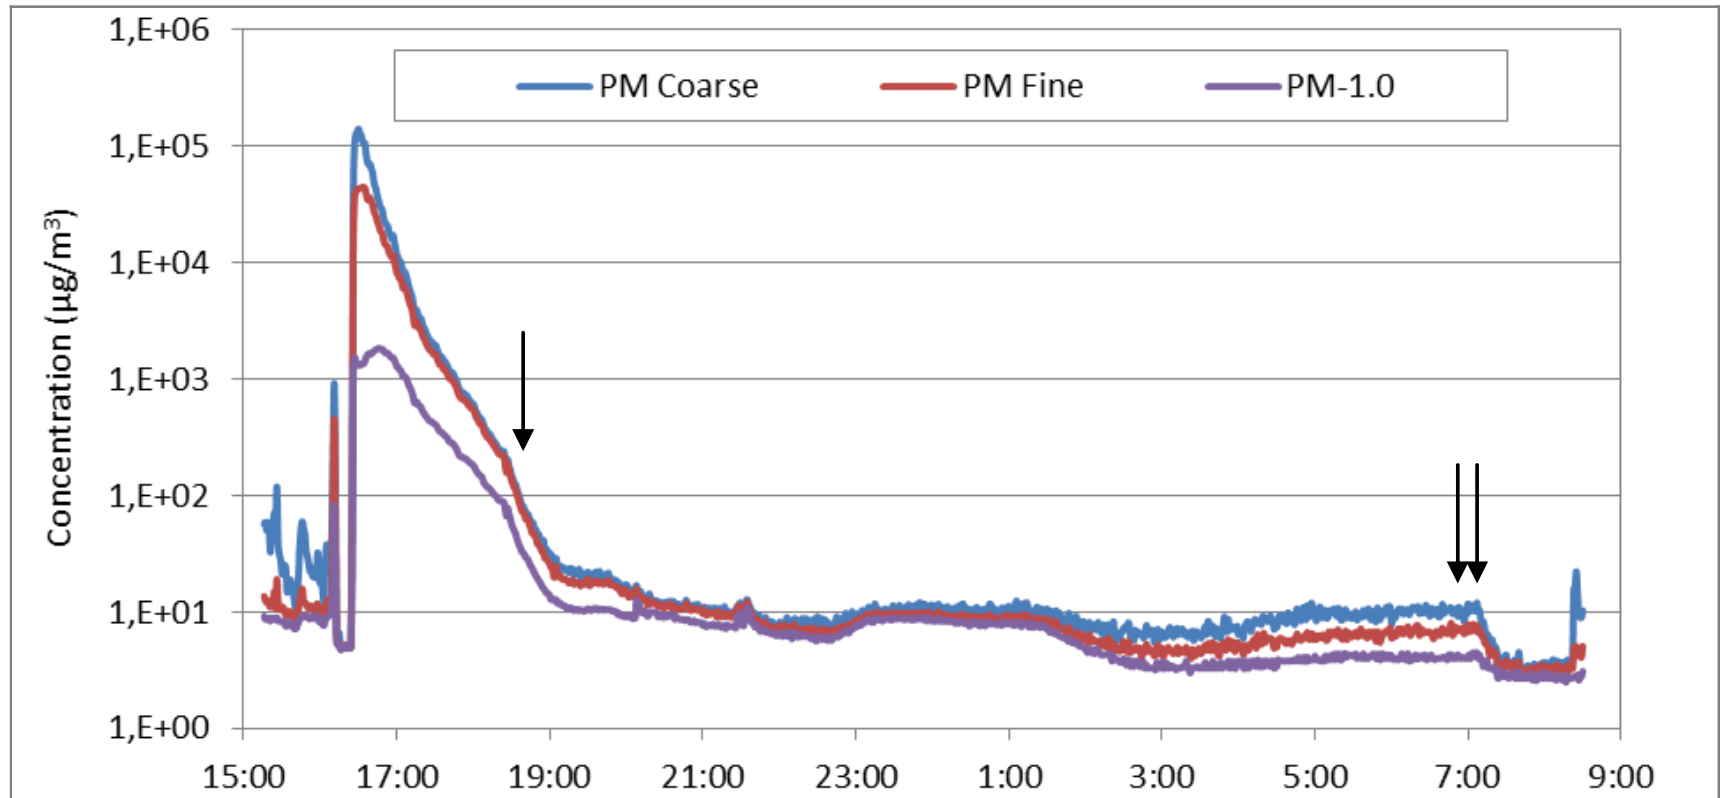
**Figure :** Trace of the Grimm spectrometer. PM Coarse corresponds to PM-10, PM Fine corresponds to PM-2.5. The drop in concentration around 8:30 pm (arrow) may have been caused by a thunderstorm passing over Nijmegen, with air velocities exceeding 100 m/s. The drop in concentration at 07:00 am (double arrow) is (presumably) caused by turning on of the ventilation system.

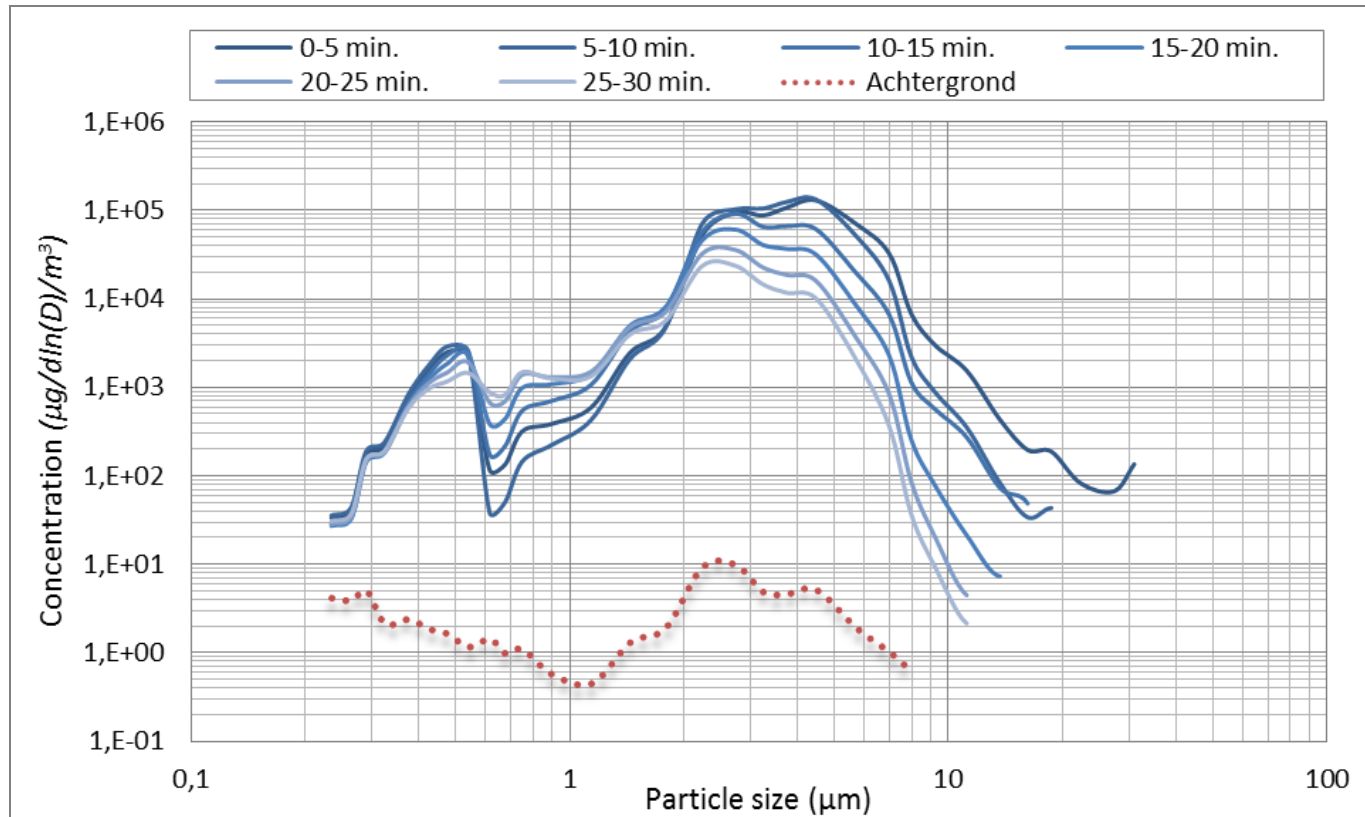
**Figure 1a:** Particle size distribution expressed by mass presented at subsequent time intervals of 5 minutes, relative to the background (estimated from  $t=-30$  to  $t=0$  min). Data from Grimm 1.109 Size selective spectrometer.

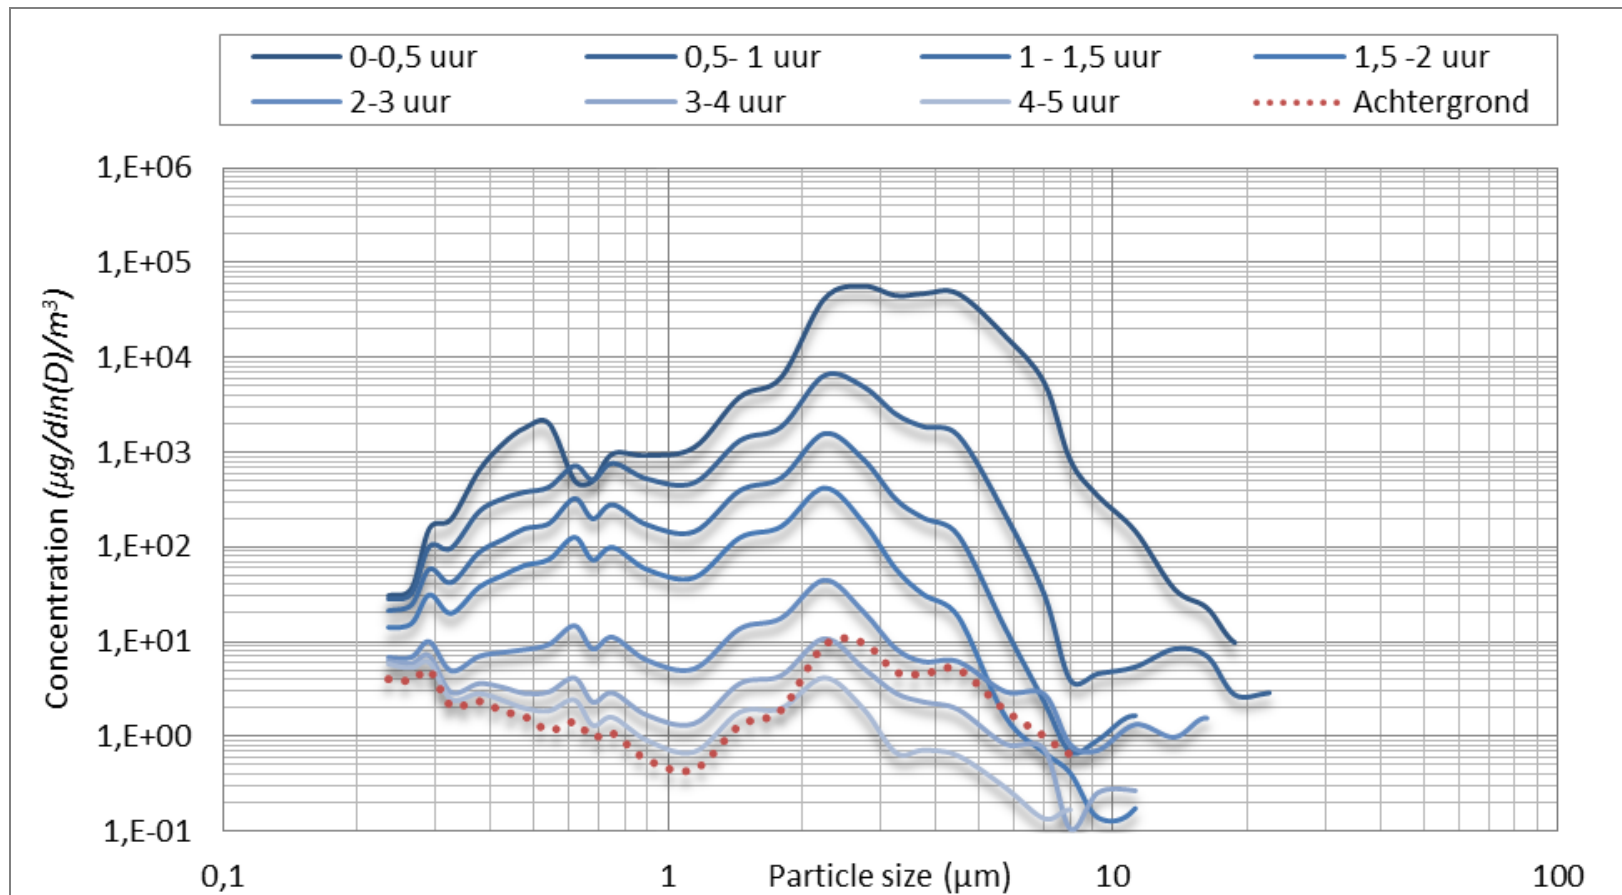
**Figure 1b:** Particle size distribution expressed by mass presented at subsequent time intervals of 30 minutes, relative to the background (estimated from  $t=-30$  to  $t=0$  min). Data from Grimm 1.109 Size selective spectrometer.

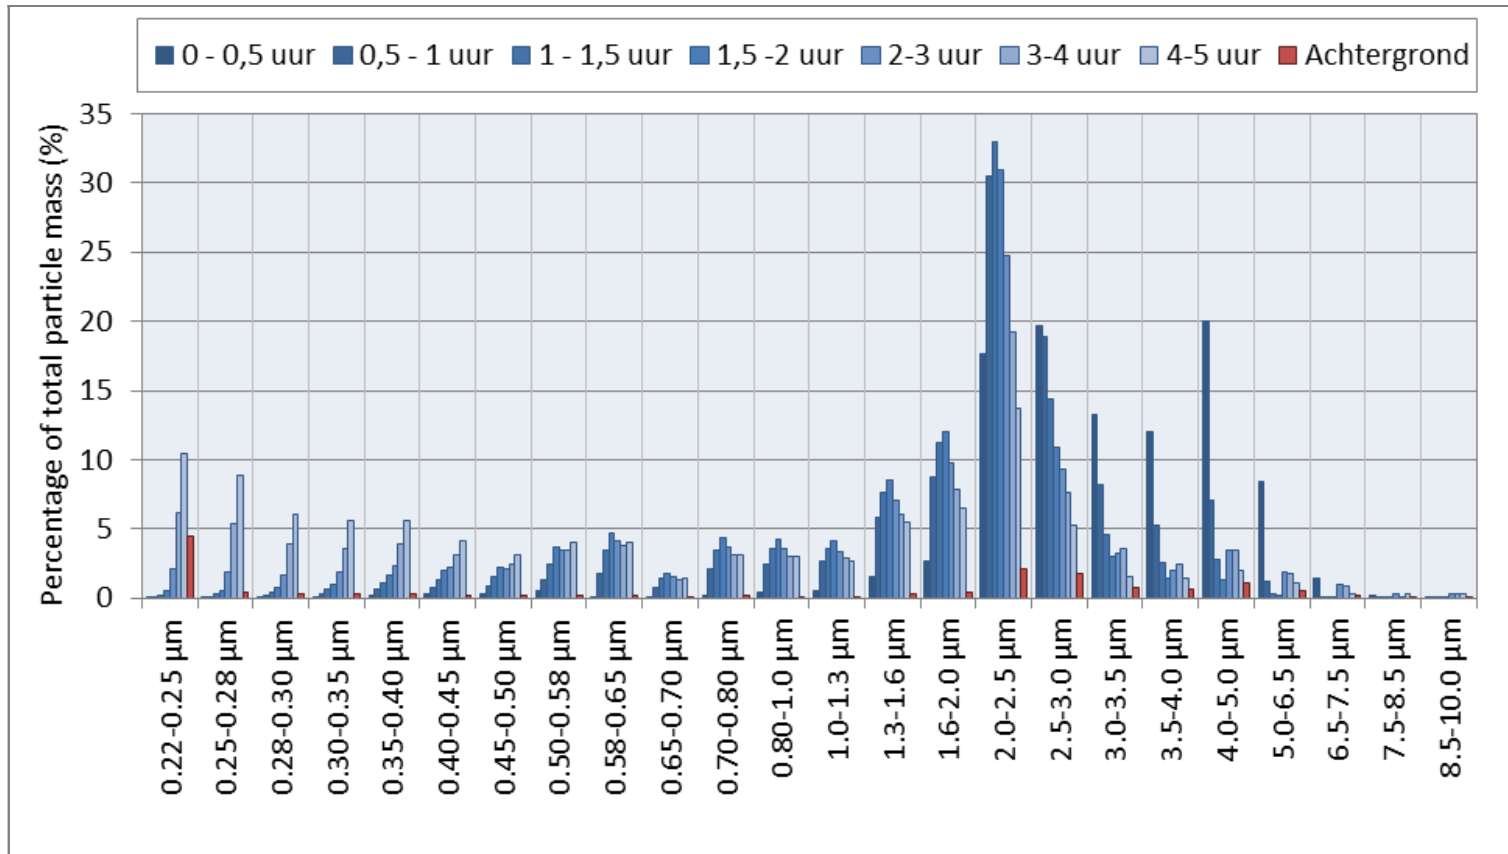
**Figure 1c:** Same data as Figure 1a (from Grimm 1.109 Size selective spectrometer) but expressed for each particle size channel separately. Again the change in time is presented for subsequent time intervals of 30 minutes.

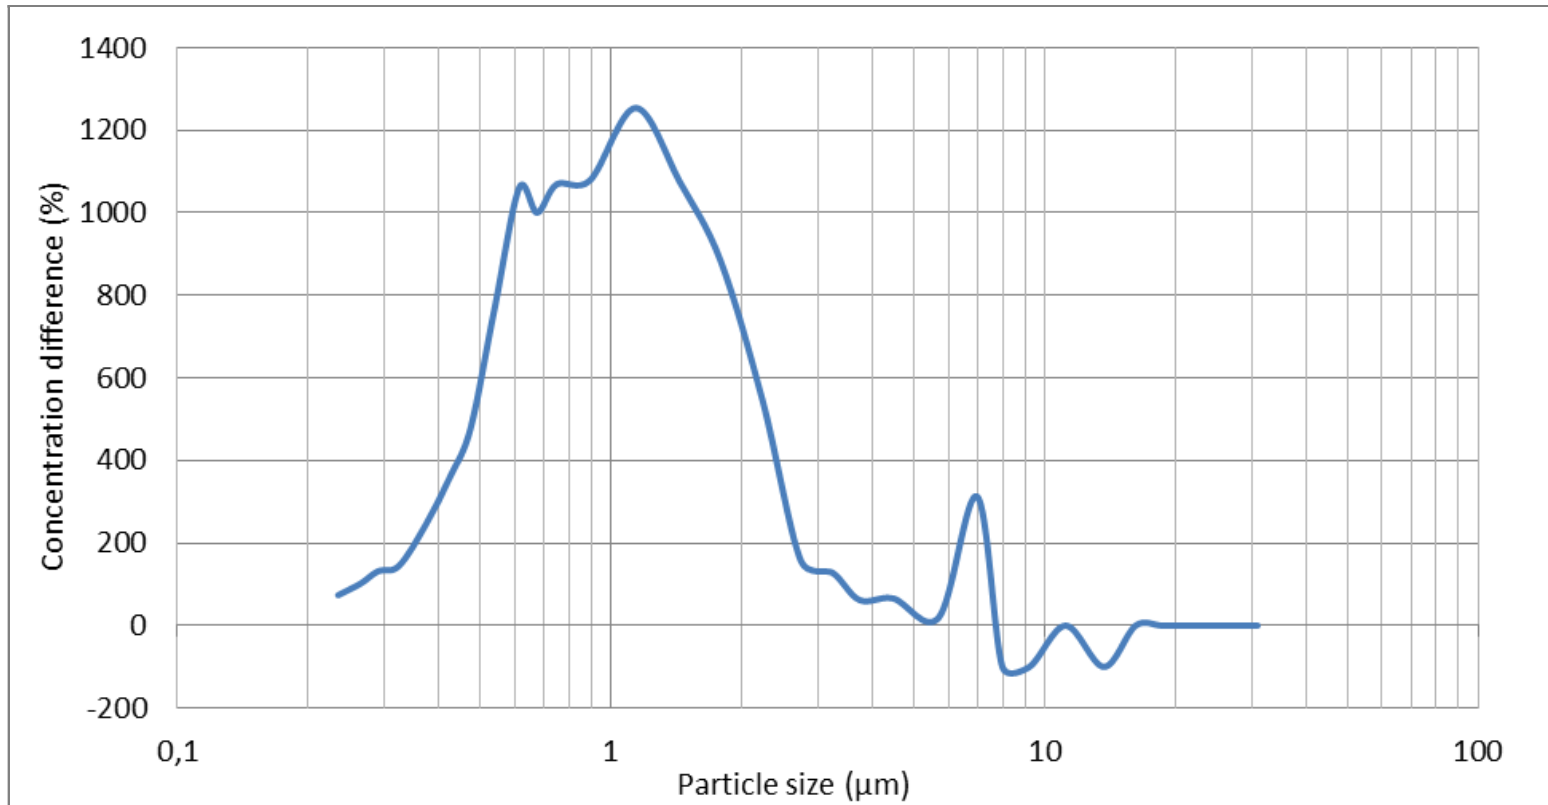
**Figure 1d:** Same data as Figure 1a (from Grimm 1.109 Size selective spectrometer) but expressed as a difference of the concentration 2,5 hours after application, relative to the background concentration for each particle size channel separately.
